Physical Properties of Five Brands of K-Files

Original Article

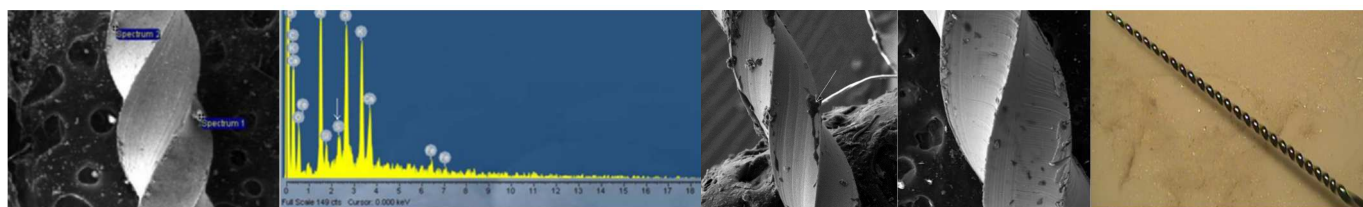
Figure 1. A) SEM micrograph of a file. Note the cavities on the surface of the file ($\times 250$ magnification); B) EDX spectrum of the cavities, C) A #25 Mani instrument under $\times 250$ magnification. The white arrow shows debris in the middle of the file; D) A #25 Larmrose instrument under $\times 250$ magnification. Machinery defects in the middle of the file, E) The flutes of a #25 Mani instrument under $\times 40$ magnification.

The existence of any cavity on the surface of the files was considered as a sign of corrosion [21]. Figure 1A shows the SEM micrograph of a file. Some small cavities are obvious on the outer surface of the file. These corroded points were assessed by energy dispersive x-ray microanalysis (EDX). The presence of sulfur in the EDX spectrum confirms the occurrence of corrosion [22]. For instance, Figure 1B shows the results of EDX analysis for the cavities in Figure 1A. The presence of sulfur in the spectrum confirms occurrence of some corrosion in the file.

SEM micrographs ($\times 250$ magnification) were taken to detect the machining debris in tip, middle and end of the file (Figure 1C).

Any visible defect in the file structure is considered as a machinery defect. This includes discontinuity of flutes, flute curvature, metal flushes or any other observable structural defect after opening the package of the files [23]. In Figure 1D, machinery defects are clearly seen in the middle of the file.

The number of shiny points in the stereomicroscope micrograph (under $\times 40$ magnification) is defined as flutes number. For instance, the number of flutes in the file shown in Figure 1E is 27.

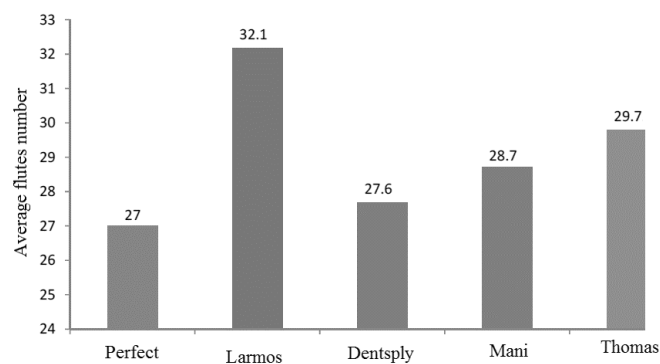
Figure 3. The number of flutes in the studied files

The average flutes number in the studied files is shown in Figure 3. The Larmrose files showed the highest flutes number, while the lowest number of flutes was found in Perfect files. A significant difference was observed between these two brands while the other brands showed no significant difference.
